The Performance of House Foundations in the Canterbury Earthquakes

Master of Engineering in Civil Engineering

Duncan Henderson

August, 2013

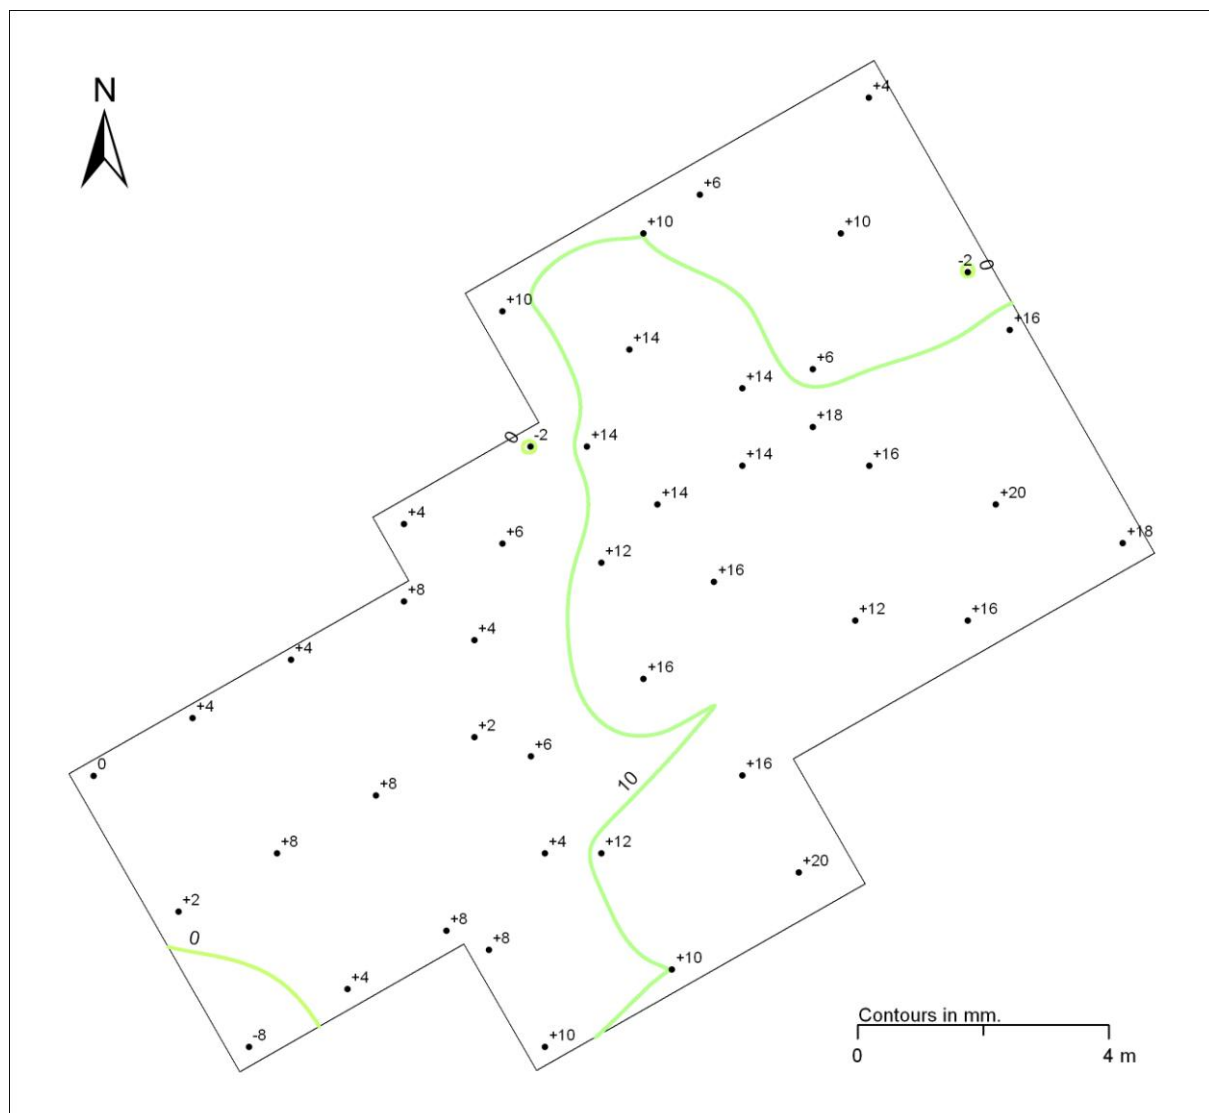
Foundation damage was low overall. There was a maximum of 28mm of differential settlement along the length of the house, for an overall slope of 0.1° . The maximum tilt measured was 0.4° found in two locations.

The building had low damage overall, with minimal settlement. Local distortion of the floor was also low, with only two tilt measurements of 0.4° taken, the rest being 0° , 0.1° or 0.2° . The overall differential settlement was 28mm over the length of the house, too small to say the house has settled in any direction. There was no evidence of global settlement of the house relative to the surrounding land.

Figure 12. Floor plan showing floor levels and contours.
